Tiling Mangers to Improve Dry Matter Intake and Clean Ability

Summer 2010

By Zen Miller

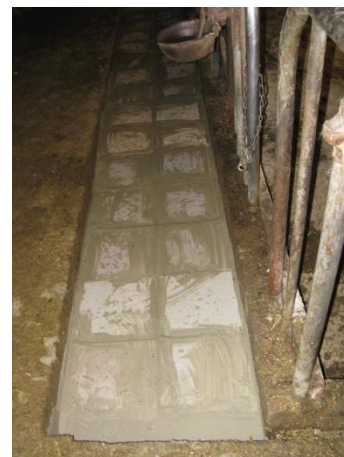
On June 4, 2010 I went to a farm by Clintonville, Wisconsin. We laid tile in a section of manger that was 2' wide and about 56' long. We did the south west part of the stanchion barn. There were 7 tiles left over so we did the first stall on the southeast side as well. I purchased six bags of Kwik Crete sand mix and we were a bag short of having enough. I purchased 56 tiles that were 12"x 12" and one tile was broken by a cow while in storage. There was a hole in the manger because the concrete had deteriorated. We mixed the sand mix in a wheel barrow and the water standing in the manger made it plenty wet. We trowled the concrete mix in and laid the tile imbedded in the mix. We used a level to try and keep the pitch to one direction and keep our new surface tiles somewhat level. 12"x 12" tiles cost \$.50 per tile at

the Restore in Appleton. Cows needed to stay off the tiles and manger for 2-3 milkings depending on depth of Kwik Crete laid in manger and how wet the mix was when used.

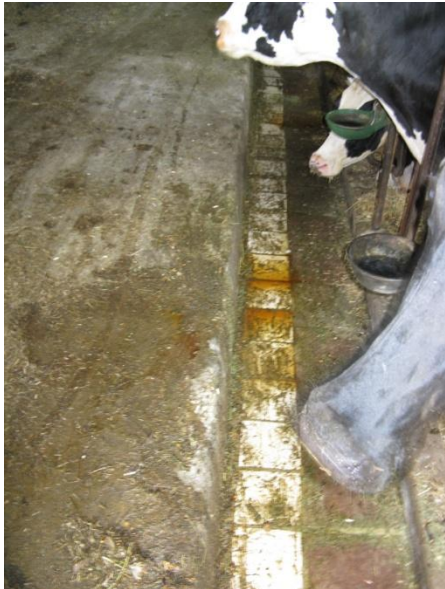
On July 6, 2010 I worked with a dairy producer to fix part of their manger. Again, it was the old southwest part of the manger in the stanchion barn. The manger was not a complete 24" wide so we had to go back to the ReStore and purchase 8" tile to go with the 12 " tile. We used a power

washer to clean the concrete bottom of the manger. This was faster and a better wash. There was a hole in the manger as well as having the concrete broken through under a water cup that had

leaked. We cleaned about 60 feet of manger about 16 stalls. I purchased eight bags of Kwik Crete sand mix and should have bought ten bags. These stalls were 45" wide. In the end we used a concrete patch mix that was left from another project and still needed more concrete so we left about 1.5 stalls undone. The water in the manger dips made the Kwik Crete to wet, so a shop vac was employed to suck the water out and left a wet surface with no standing water. We still used a level and only had a couple of dips and high spots when we were done.

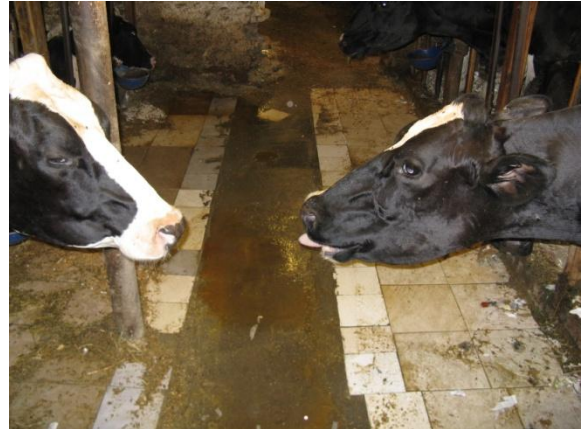
In August a third dairy farm used left over tiles to cover a section of manger that was pitted and deteriorated. In this section of the barn the cows were head to head so tile were laid and sloped to the middle of the old manger to let the extra water from the drinking cups run away from the feed. Also the middle of the aisle / manger was not tiled but left with smooth concrete so the farmer would not slip as easily when feeding the cows. The

farmer used Tamms Speed Crete-Red Line that was made to set up quickly. The mix was \$15 per bag and the concrete was set up and hard before milking that night.
